EVALUATION OF THE PERFORMANCE OF POLYURETHANE FOAMS IN RIGID PAVEMENT PRESERVATION

A Thesis Submitted to the Faculty of the University of
Tennessee at Chattanooga in Partial
Fulfillment of the Requirements of the Degree
of Master of Engineering

The University of Tennessee at Chattanooga
Chattanooga, Tennessee

August 2018

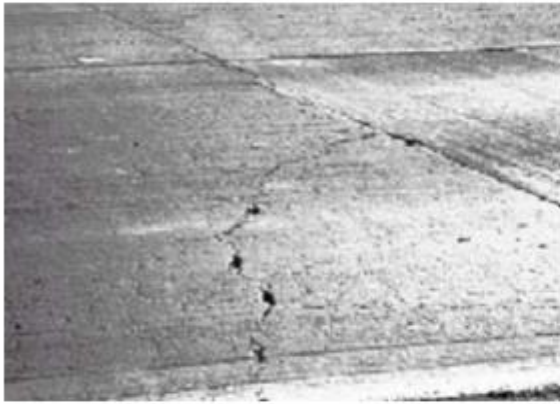
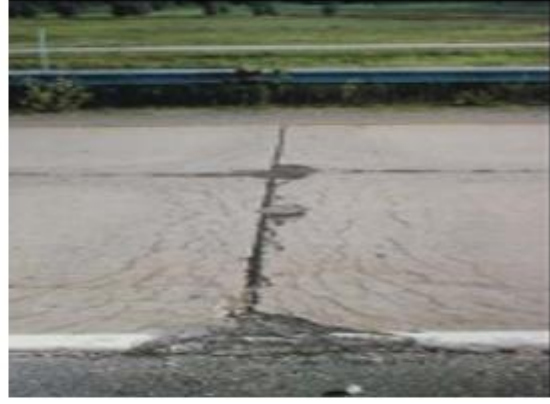
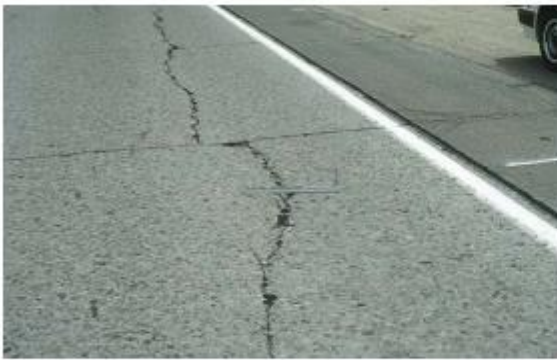
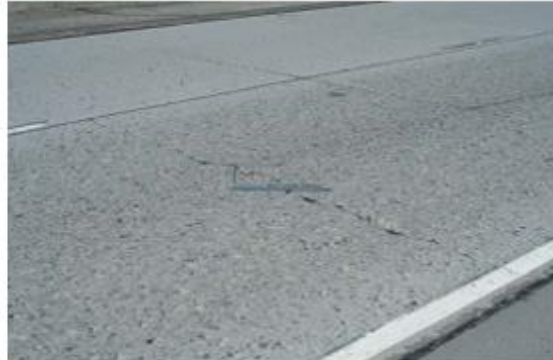
(a) Corner Cracking

(b) Durability "D" cracking

(c) Longitudinal cracking

(d) Transverse cracking

Figure 2.1 Types of cracking in rigid pavement (Source: Miller and Bellinger, 2014)

- i. Crackings in concrete pavements is a result of stresses caused by repeated traffic loading. These stresses may not even exceed the flexural strength of the concrete slab but still may lead to formation of structural cracks due to lack of uniform base support, among other things. Cracking is also influenced by weak subgrades, expansive soils, differential settlements and curling of concrete slabs due to temperature gradient (Bautista and Basheer, 2008). If not properly sealed cracks are likely to develop into concrete spalling in situation where there is erosion of subgrade/base support and crack formation as a result of moisture infiltration through cracks or joints (Bautista and Basheer, 2008). Figure 2.1 shows cracking distresses as categorized in the DIM-LTPP based on their location and formation on the pavement.

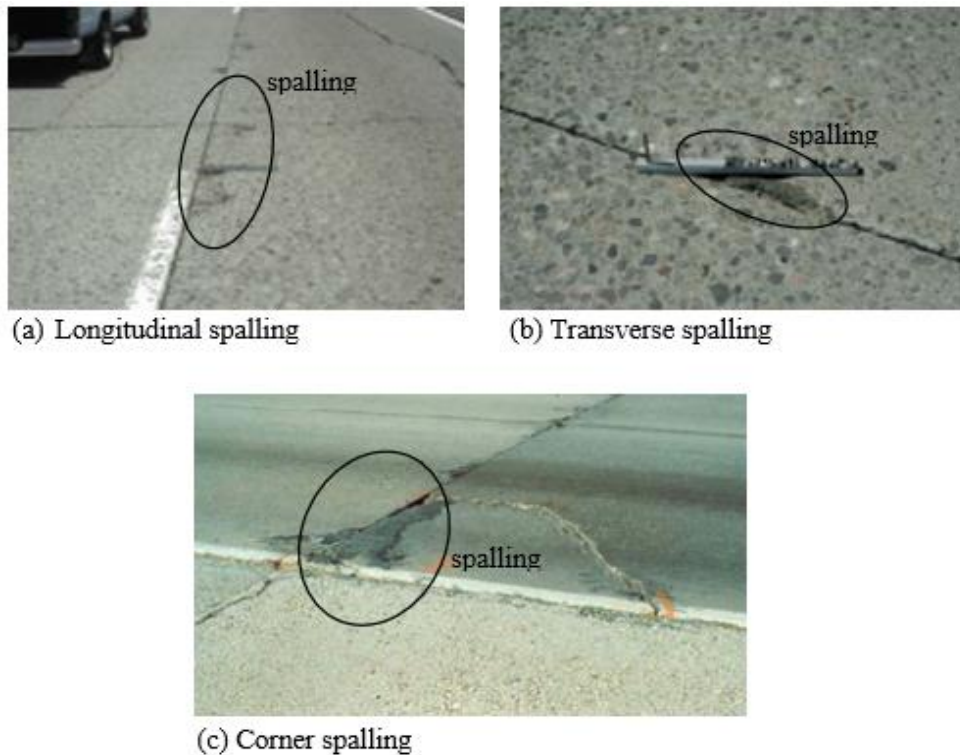
Figure 2.2 Slab spalling in rigid pavement (Source: Miller and Bellinger, 2014; North Carolina Department of Transportation, 2015)

- ii. Spalling of concrete pavement is identified by cracking, breaking, chipping or fraying of slab edge within 0.3 m from the face of longitudinal, transverse or corner of the pavement as shown in Figure 2.2 (Lee and Shields, 2010; Miller and Bellinger, 2014; North Carolina Department of Transportation, 2015).

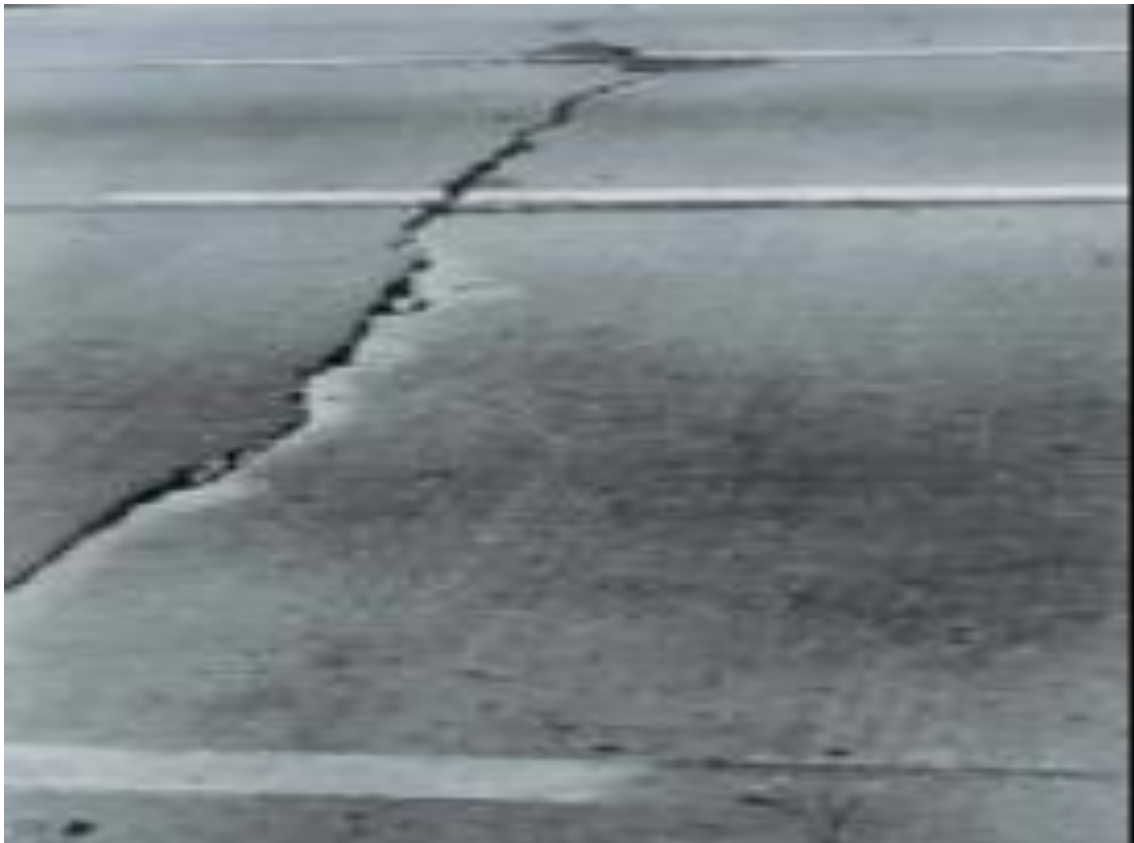
Figure 2.3 Faulting of transverse crack (Source: Miller and Bellinger (2014))

or aggregate interlock in JPCP for load transfer, sudden increases in pore pressure in wet subgrades occur, which in turn produces migration of fines and settlement under the leading edge of each slab. Where the sudden pore pressure buildup is accompanied by squirting of water and fines through the joint, the distress is referred as pumping (Huang, 2004; Papagiannakis and Masad, 2017). Faulting can be either in the longitudinal or transverse direction of the joint or crack (Figure 2.3). However, the most common ones are near the joint in the transverse direction.

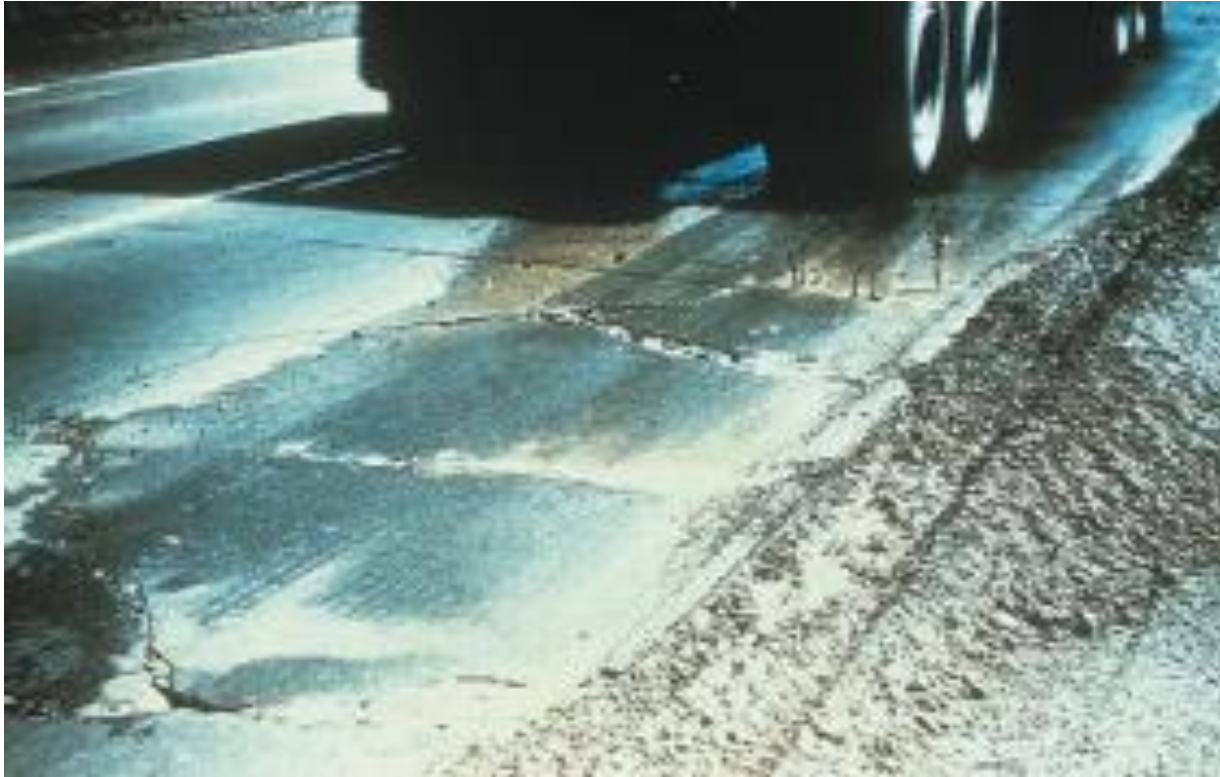
Figure 2.4 Pumping and water bleeding in JPCP (Source: Miller and Bellinger, 2014)

- iv. Pumping is the ejection of soft subgrade/subbase soil (muddy water) underneath the slab through cracks or joints, faults or along the edge of the pavement (Figure 2.4) due to slab deflection under dynamic traffic loading (Huang, 2004; Miller and Bellinger, 2014). Curling of slabs or plastic deformation of the subgrade creates void space, due to capillary forces (if the subgrade is on/under the water table) or ingress of water from the top into the subgrade through cracks or joints). The void space will be filled with fine-soft soil, when frequent passage of heavy wheel loads occur the fine-soft soil under the leading slab are pumped due its deflection to the trailing slab which had rebounded and created a vacuum; the fine material is sucked outside from underneath the leading slab through joints or cracks (Huang, 2004). Pumping and faulting are indicators of loss of slab support and likely to cause corner cracking.

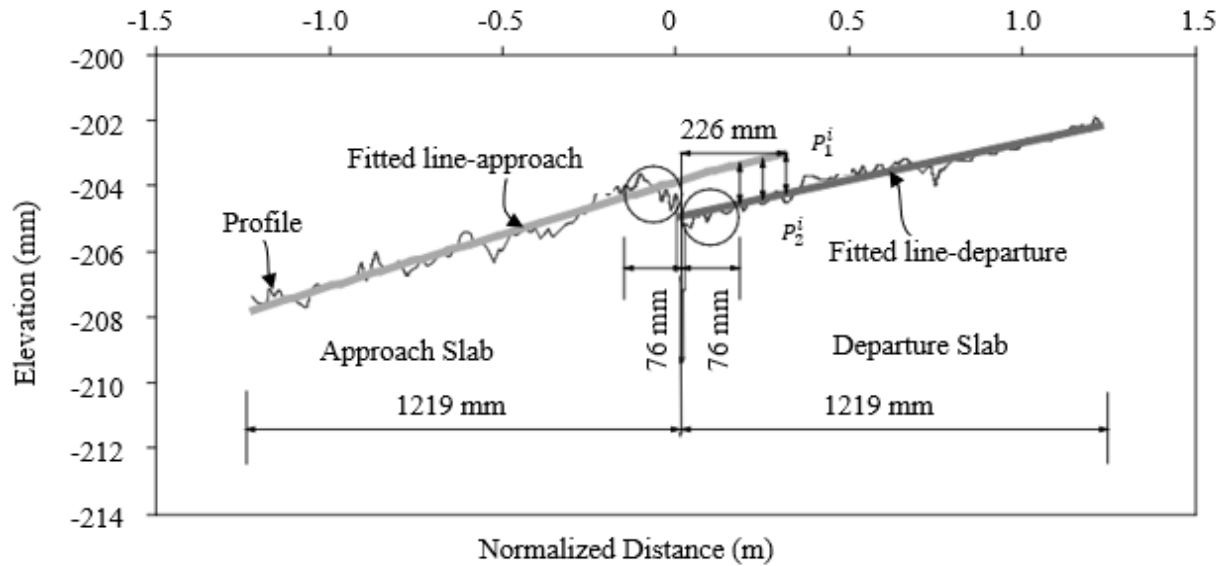
Figure 3.1 Cropped profile slices curve fitting and faulting computation (Source: Chang et al. [2012])

approach slab slice is recorded as P_1^i , and its corresponding elevation points from the departure slab slice as P_2^i .

- vi. The faulting value is computed by averaging the difference between the elevations data points (P_1^i and P_2^i) obtained in iv above.

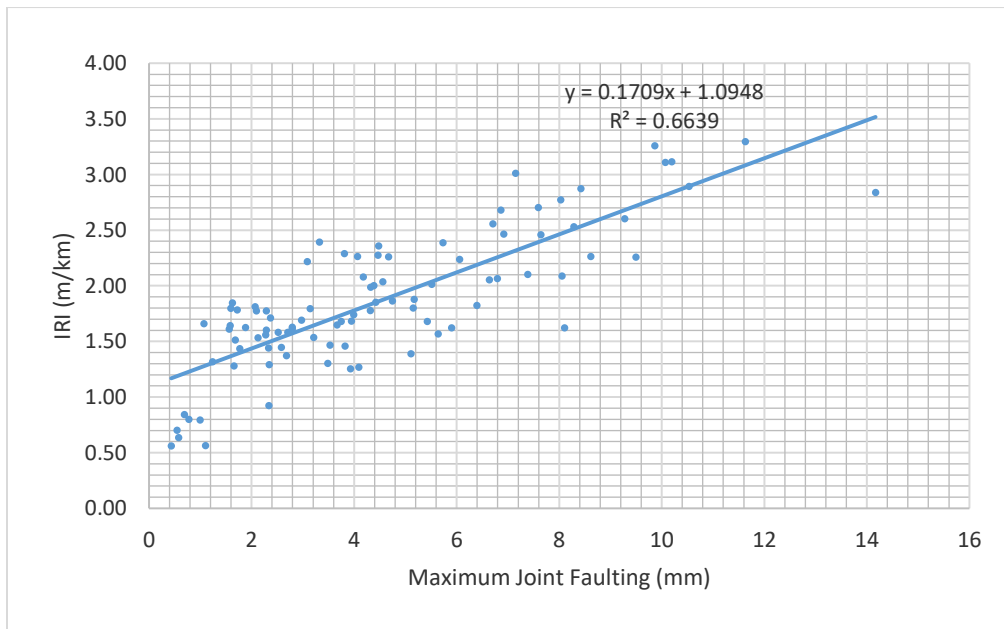
Figure 4.1 IRI against maximum transverse joint faulting for left wheel truck

Furthermore, maximum transverse joint faulting and mean IRI values in each 100 m segments from all the five sections were combined and correlated to obtain the relationship between the two indicators, for the left and right wheel track/path. Figure 4.1 and 4.3 show that

mean IRI increases with increase in maximum transverse joint faulting for both wheel paths. Positive y-intercepts (i.e., 1.0948 and 1.2045) indicates that IRI is affected partly with transverse joint faulting. Other distress such as spalling, and punchouts have an effect on IRI too. In general, R-squared values of 0.6639 and 0.5867 indicate that the simple linear regression model/equation fits the data well. Also, the residuals against the fitted value (transverse joint faulting) plots are approximately evenly spread and randomly distributed above and below 0, which further shows that the linear regression equation is a good fit of the data (Figure 4.2 and 4.4). The relation between the maximum joint faulting and IRI may be explained by using this simple linear equation.

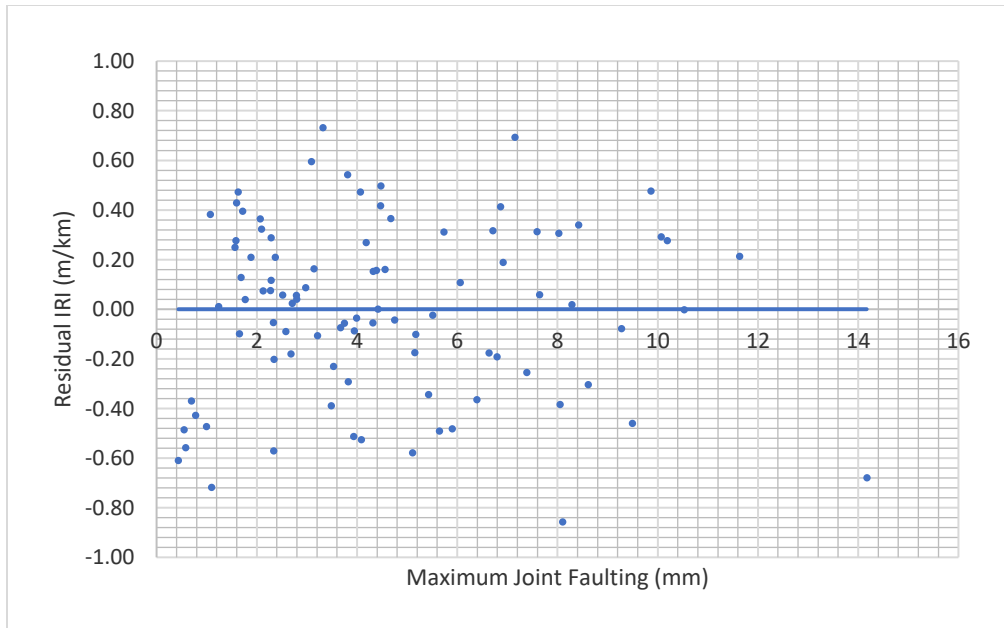
Figure 4.2 Residual IRI against maximum transverse joint faulting for left wheel truck

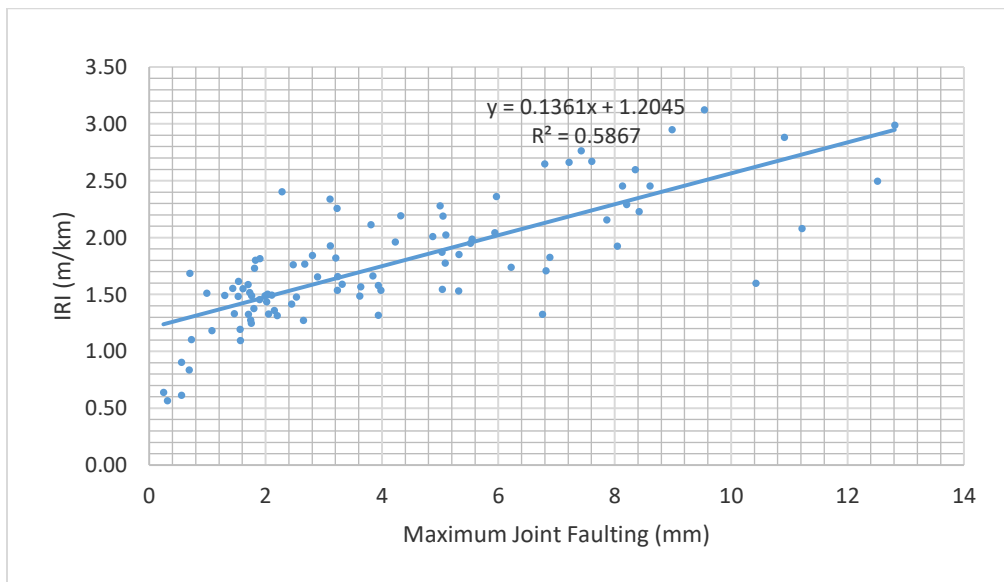
Figure 4.3 IRI against maximum transverse joint faulting for right wheel truck

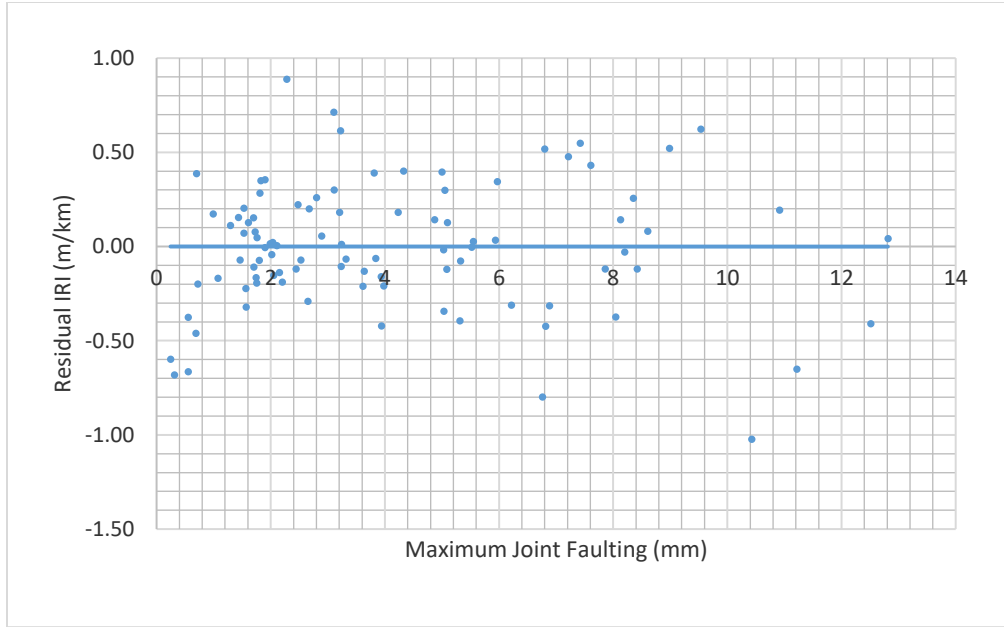
Figure 4.4 Residual IRI against maximum transverse joint faulting for right wheel truck

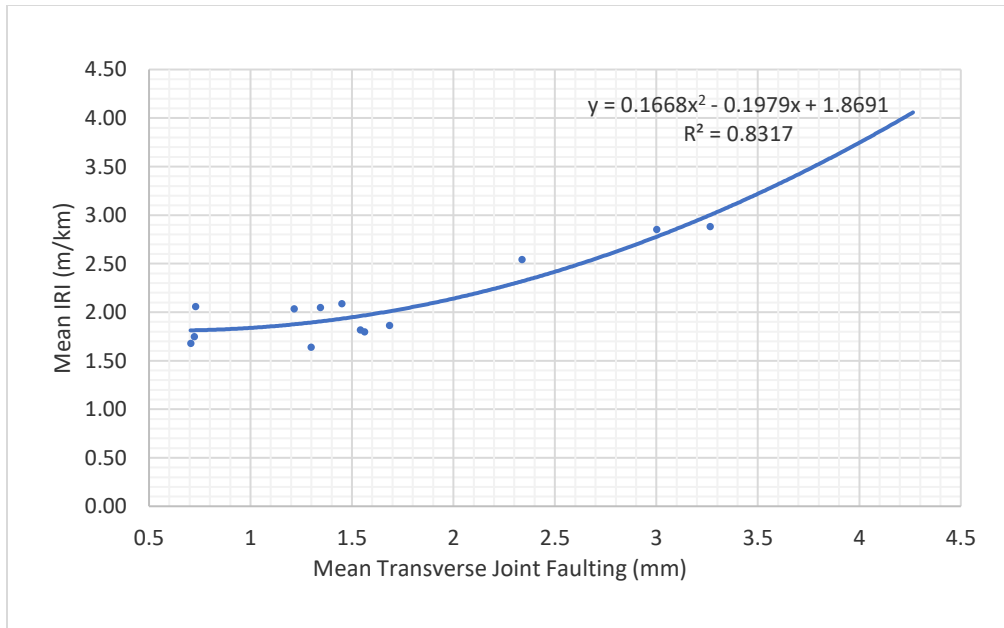
Figure 4.5 Mean IRI against mean transverse joint faulting

The overall absolute transverse joint faulting and mean IRI of the five sections in Tables 4.2 and 4.3 respectively were combined to obtain more samples for statistical correlation. The aggregated data is plotted as shown in Figure 4.5 to obtain the relationship between IRI and transverse joint faulting. It is observed that IRI increases with the increase of the mean transverse joint faulting, and they are polynomially related with a coefficient of determination of 0.83. The evenly distributed residuals above and below the zero line in Figure 4.6 further indicates that the model fits the data properly.

Also, the long-term performance of polyurethane treated sections before it requires any maintenance or reconstruction work can be roughly forecasted by using curves fitted in Figure 4.5 and 4.7 or their respective model equations. In this case, the Tennessee DOT can choose either IRI

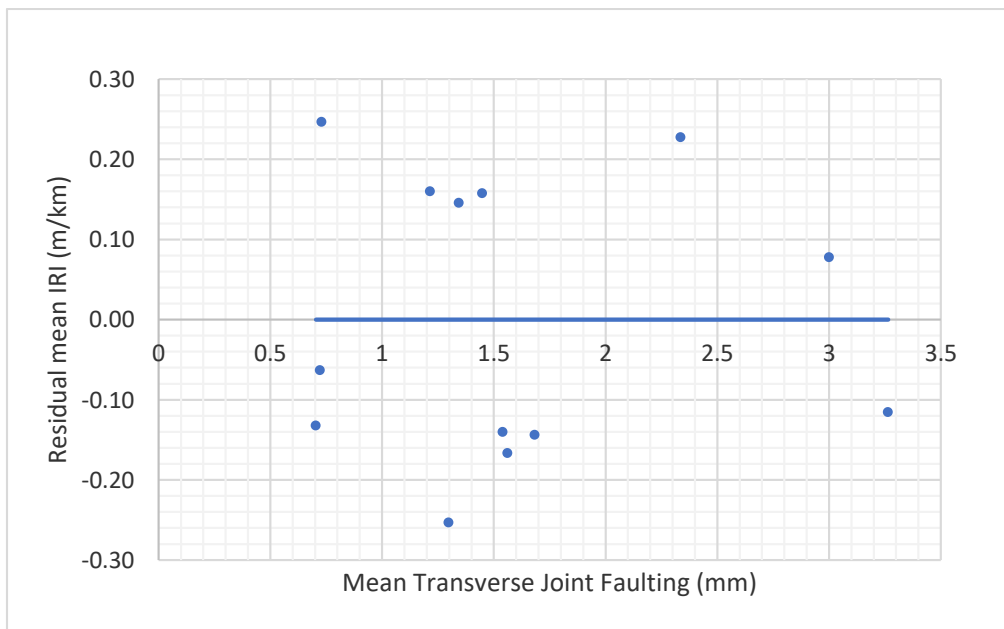
Figure 4.6 Residual mean IRI against mean transverse joint faulting

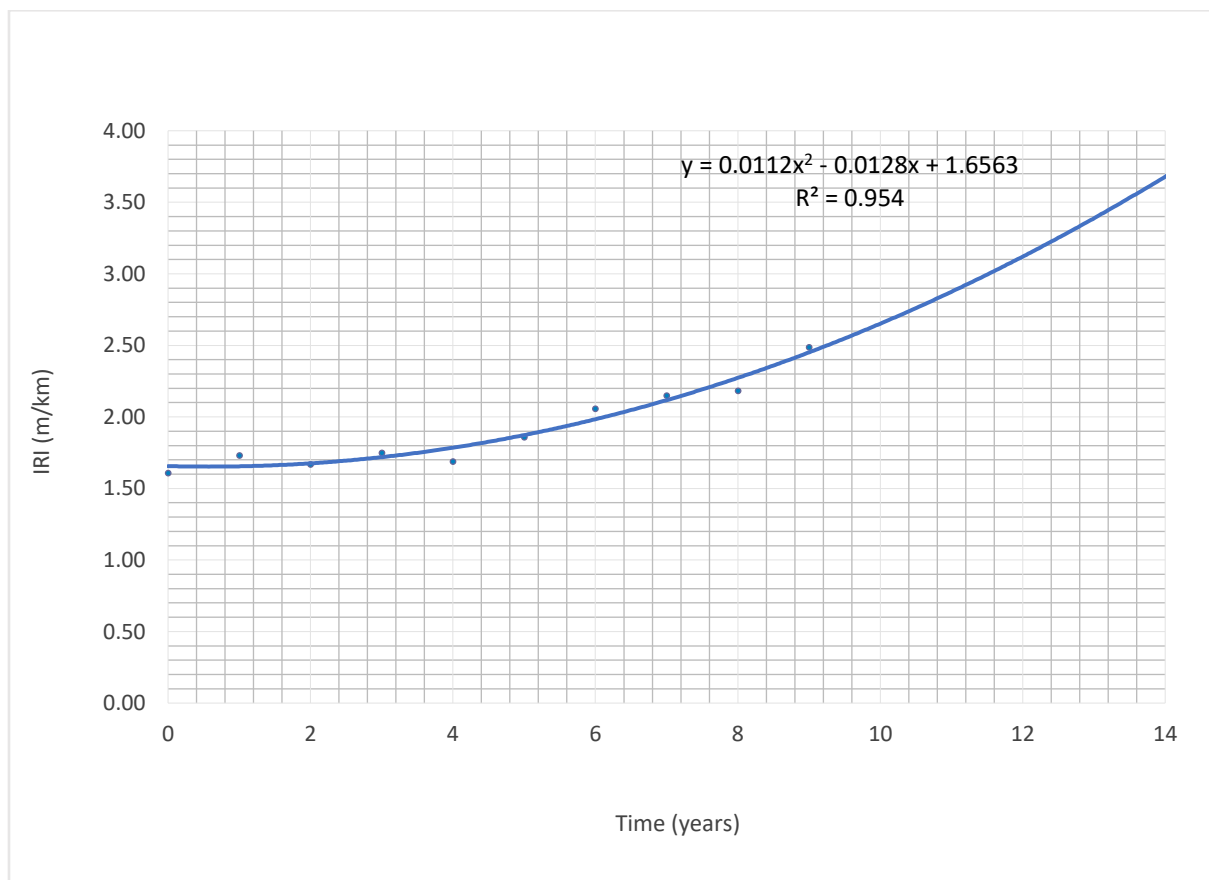
Figure 4.7 Overall IRI trend over time

IRI data collected from the year 2005 to 2014 (prior to the application of the material) were obtained from the Tennessee DOT and analyzed. The IRI data obtained were from lane 1 of I-24 East from mile marker 11.3 to 12.1. There was no maintenance/repair performed on the section in

this period. This data was plotted in Figure 4.7 as IRI versus time (in years). The fitted curve on Figure 4.7 indicates that IRI increases over time if no maintenance is applied.

The Tennessee DOT can use Figure 4.7 in timing maintenance need of its concrete pavement sections on I-75 and I-24, if it uses IRI as one of its trigger criteria. A validation of the fitted performance prediction model will be needed for it to be applied on different traffic conditions.

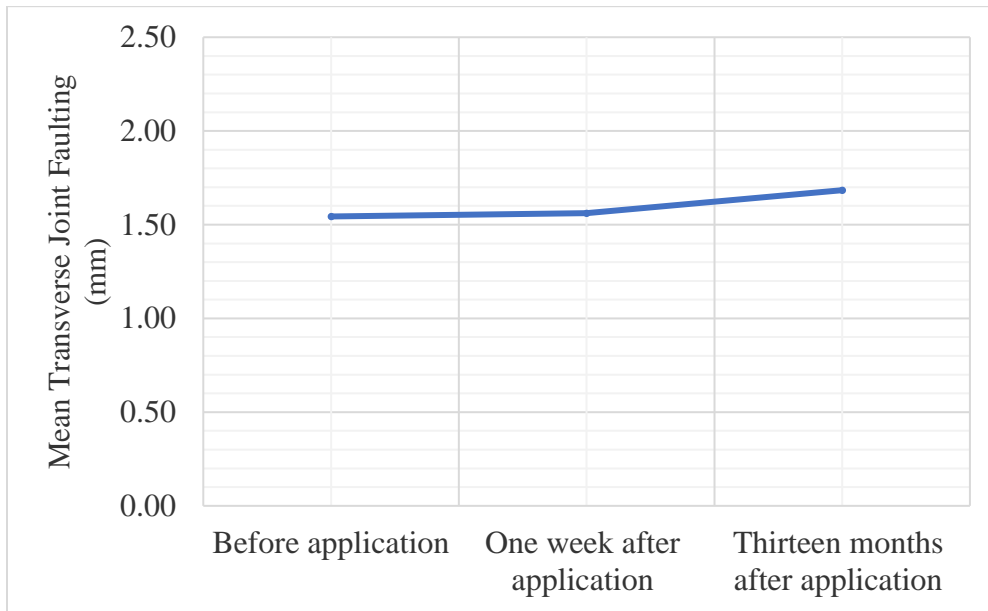
Figure A1 Variation of mean transverse joint faulting over time for section I-75 South

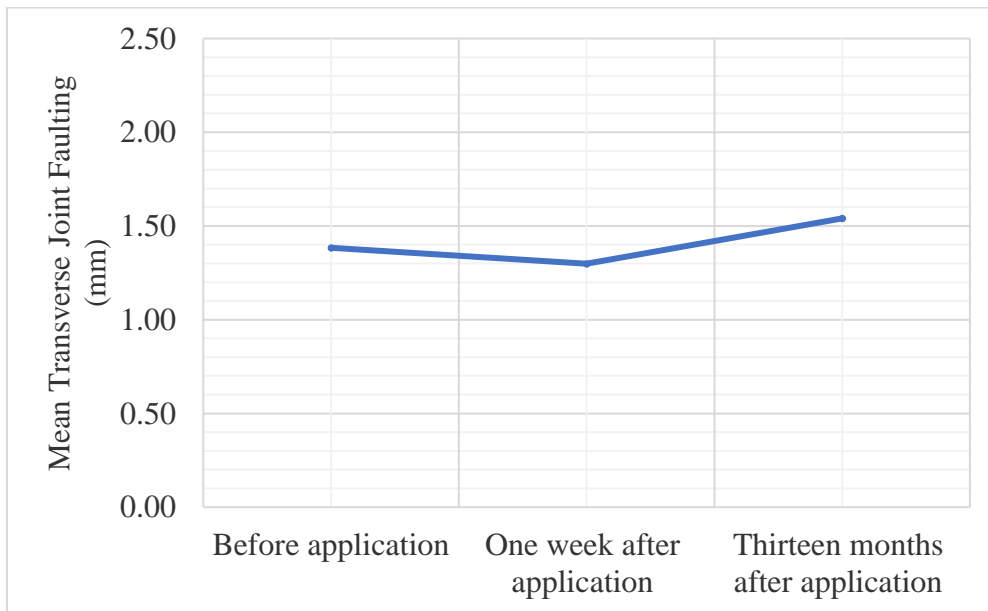
Figure A2 Variation of mean transverse joint faulting over time for section I-75 North

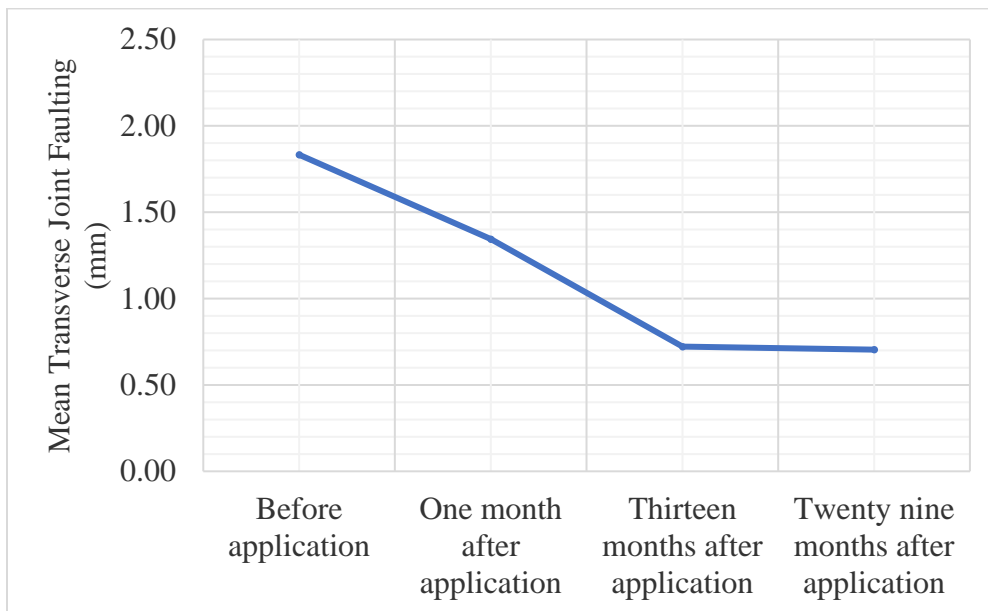
Figure A3 Variation of mean transverse joint faulting over time for section I-24 East_Moore

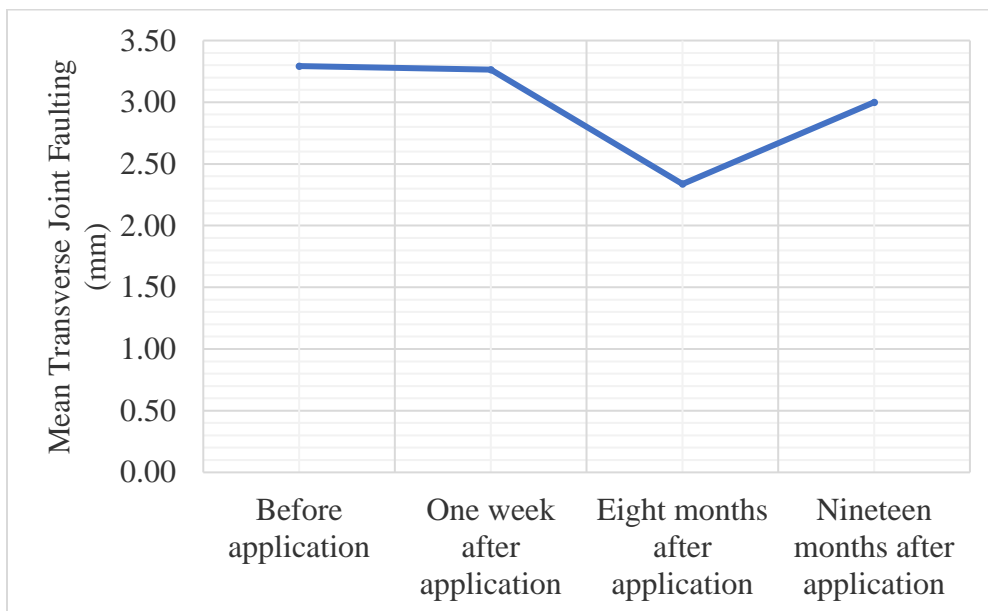
Figure A4 Variation of mean transverse joint faulting over time for section I-24 East_182

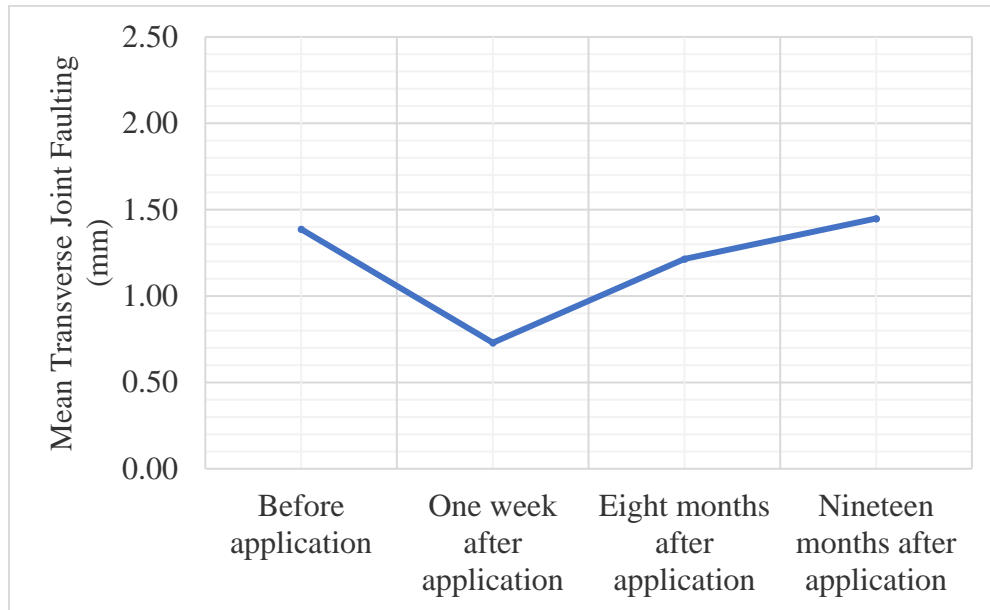
Figure A5 Variation of mean transverse joint faulting over time for section I-24 West

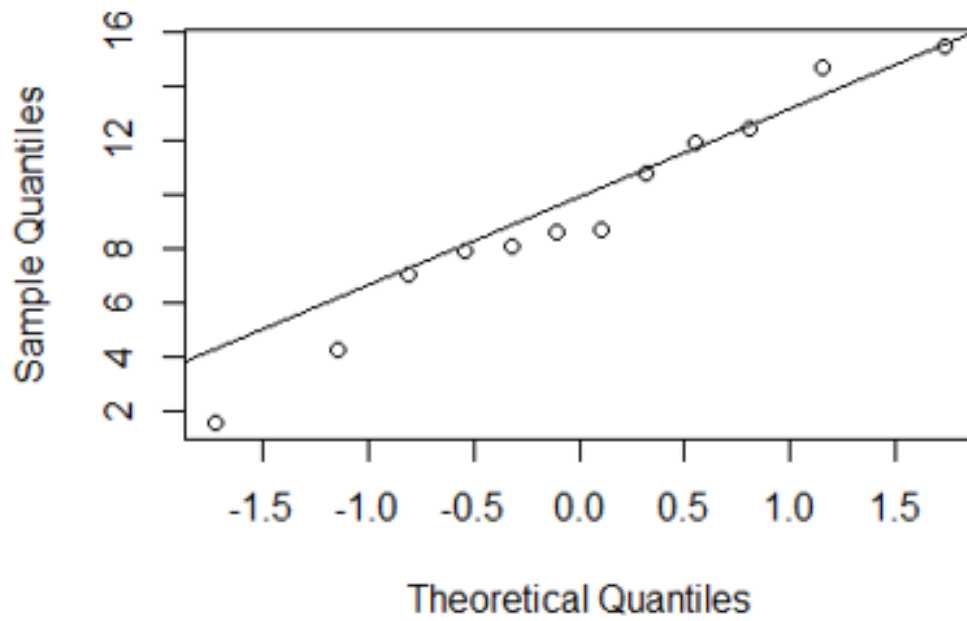
Figure C21 Left wheel track_Before application of HDP foams

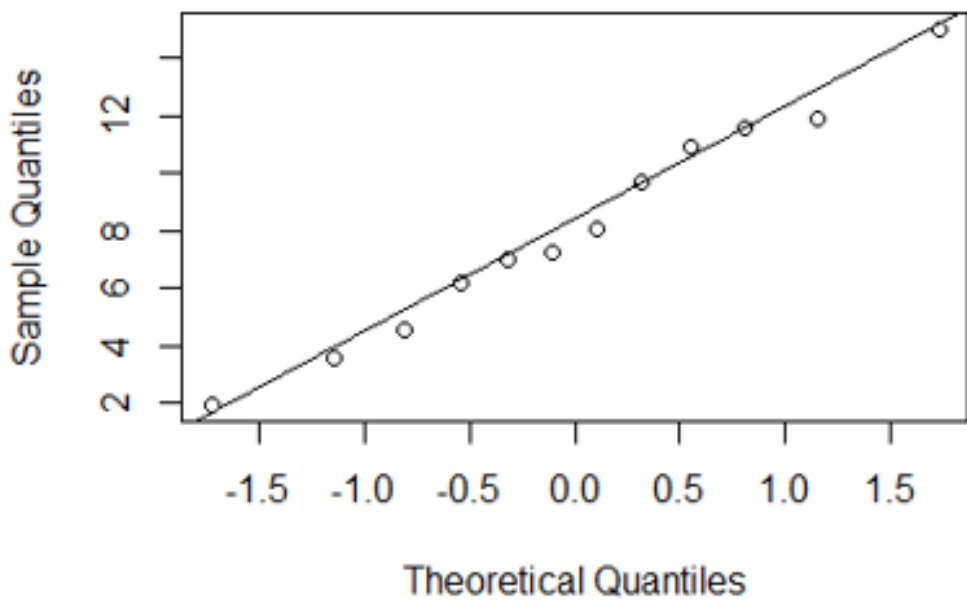
Figure C22 Right wheel track_Before application of HDP foams

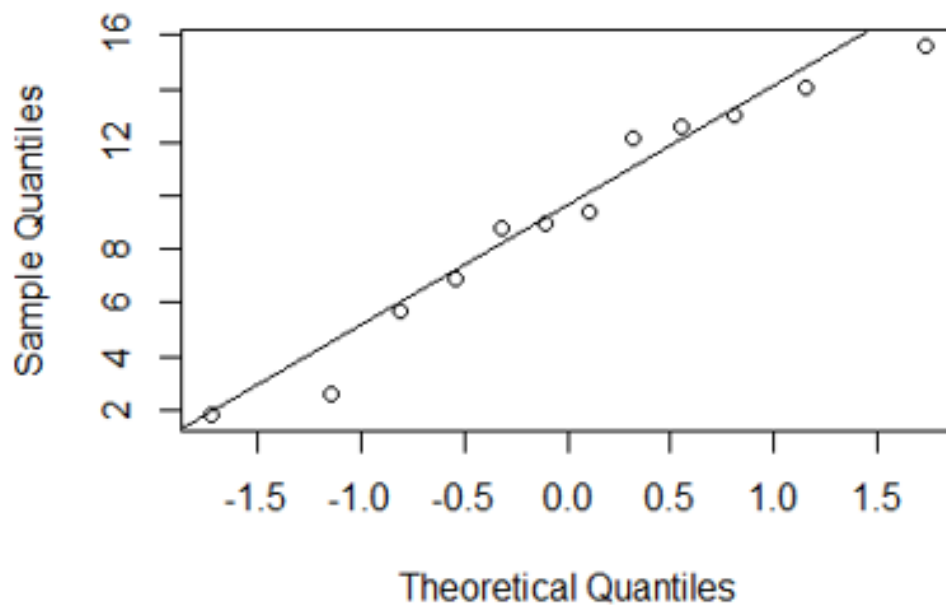
Figure C23 Left wheel track_One week after application of HDP foams

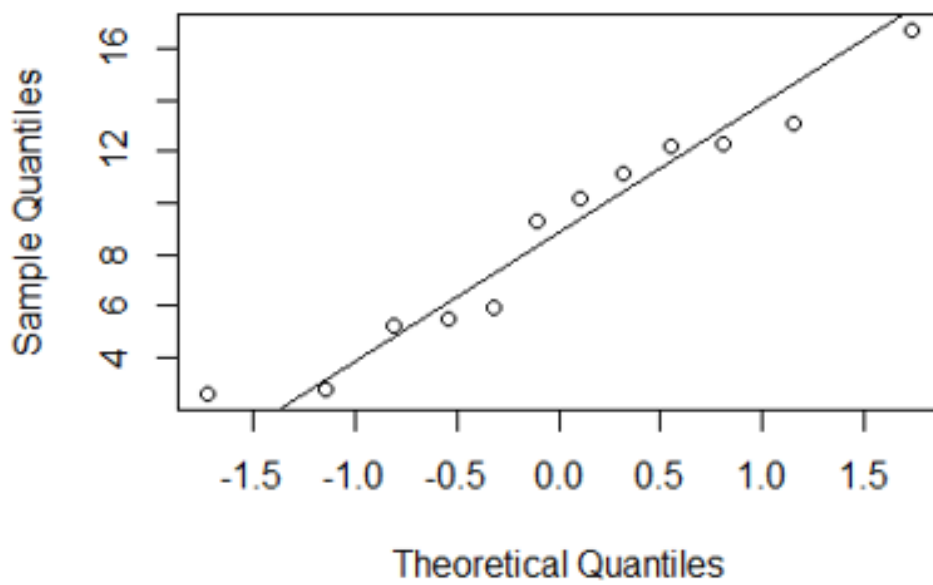
Figure C24 Right wheel track_One week after application of HDP foams

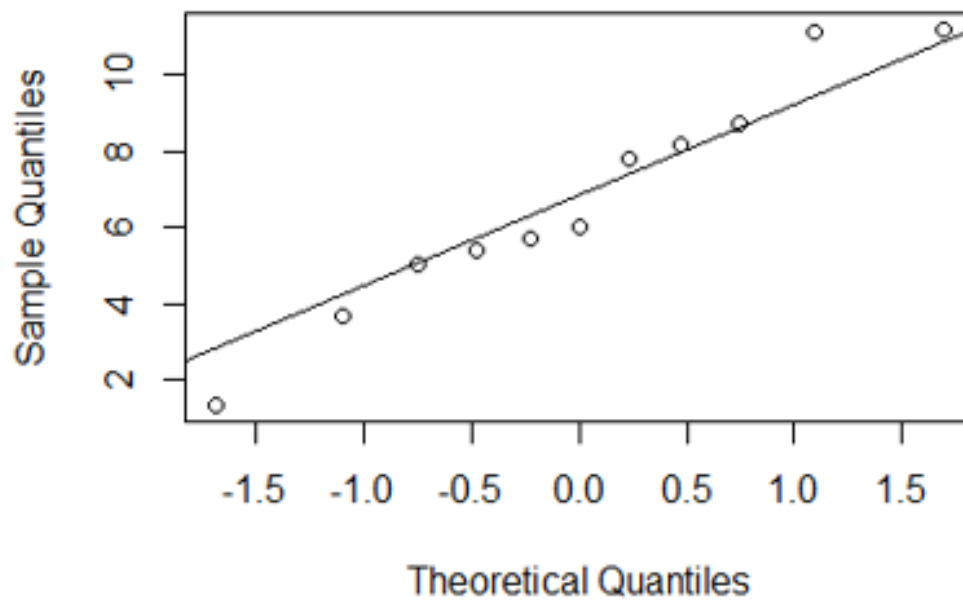
Figure C25 Left wheel track_Eight months after application of HDP foams

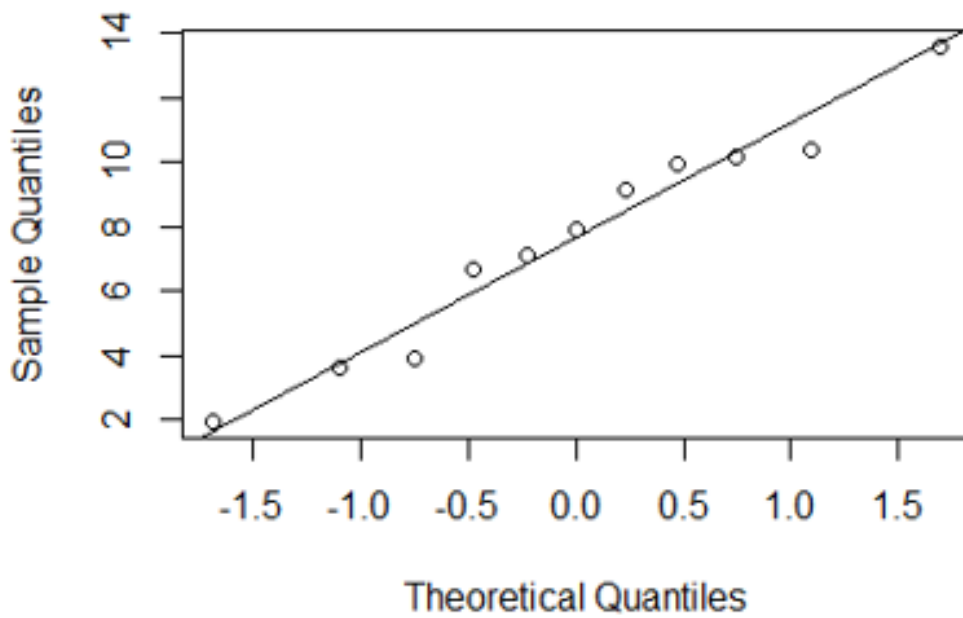
Figure C26 Right wheel track_Eight months after application of HDP foams

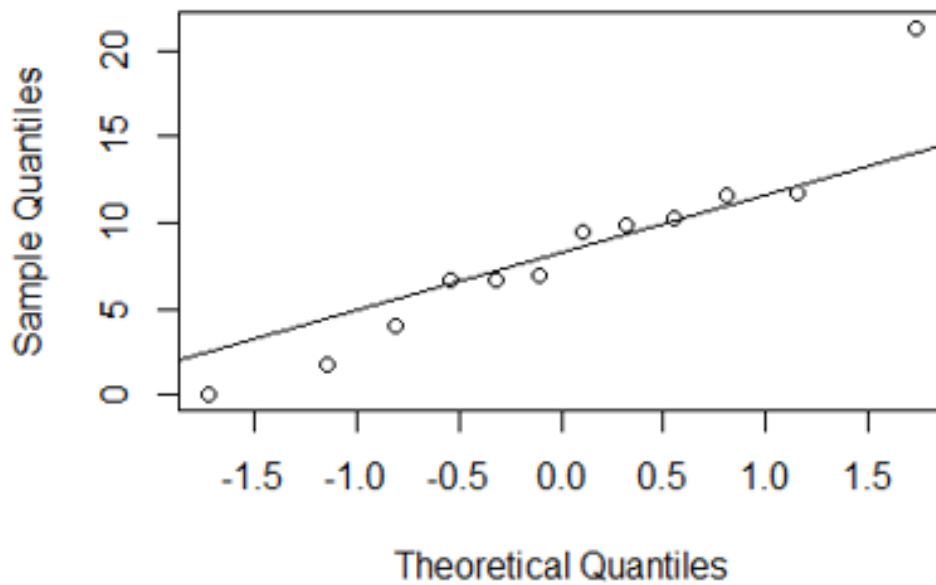
Figure C27 Left wheel track_Nineteen months after application of HDP foams

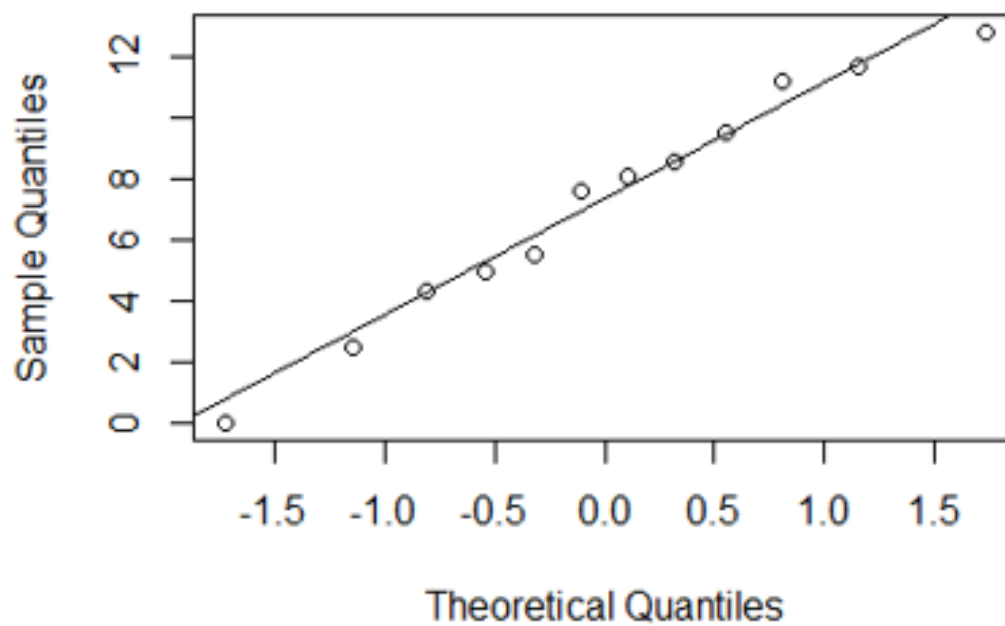
Figure C28 Right wheel track_Nineteen months after application of HDP foams

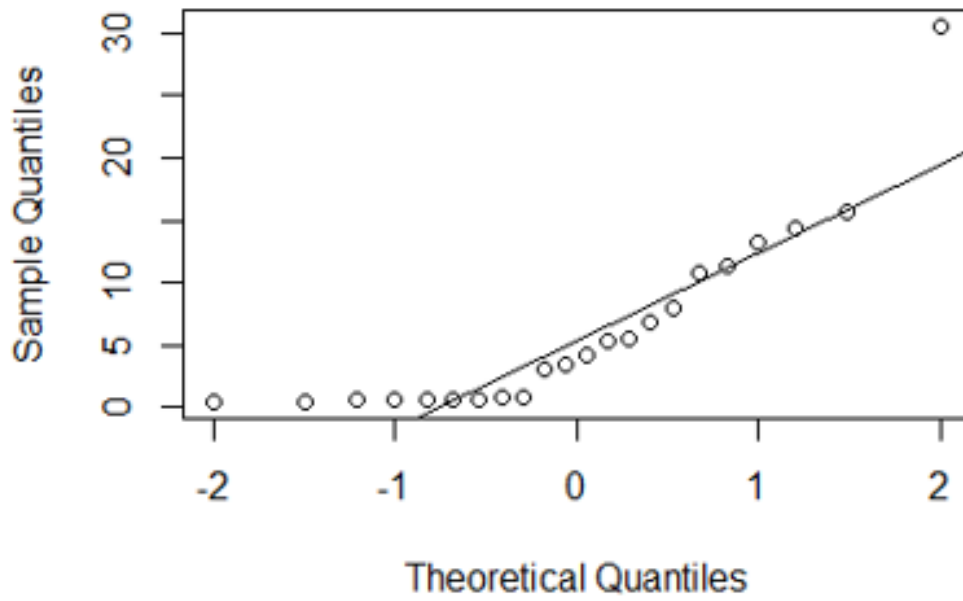
Figure C29 Left wheel track_Before application of HDP foams

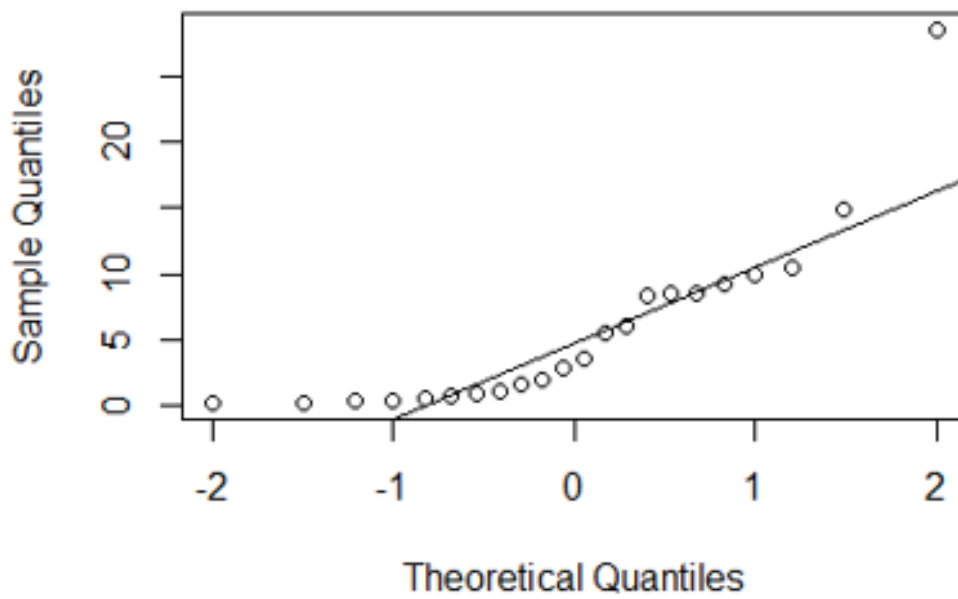
Figure C30 Right wheel track_Before application of HDP foams

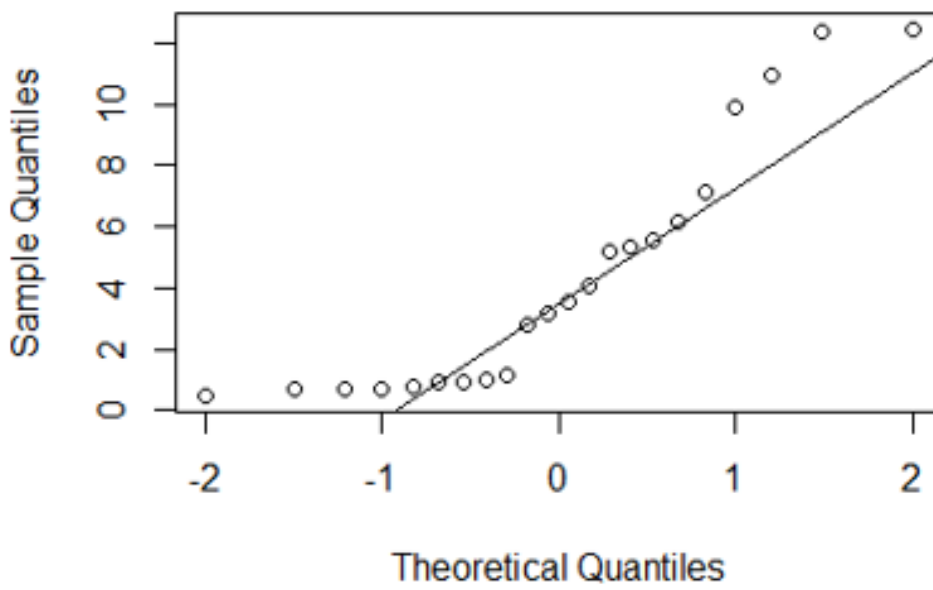
Figure C31 Left wheel track_One week after application of HDP foams

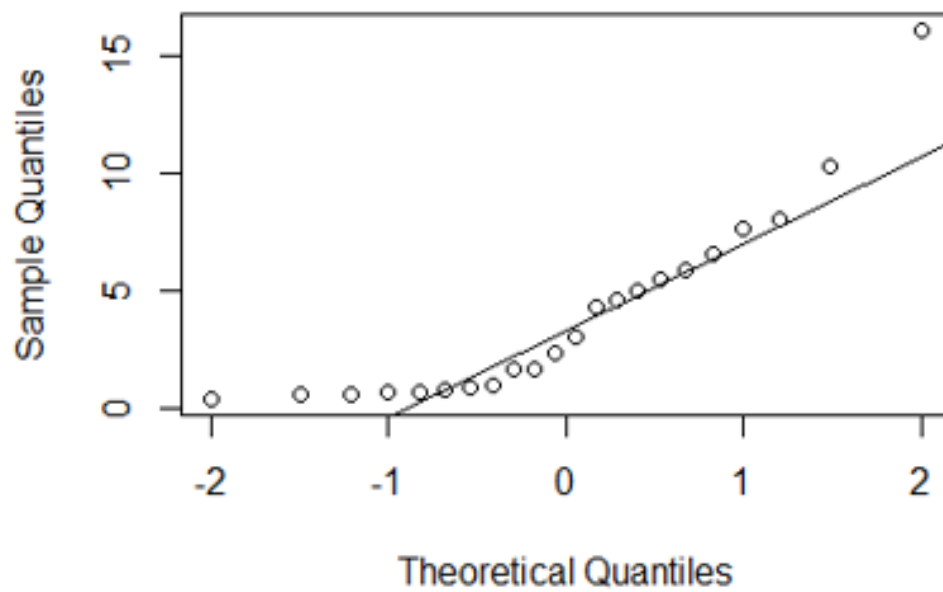
Figure C32 Right wheel track_One week after application of HDP foams

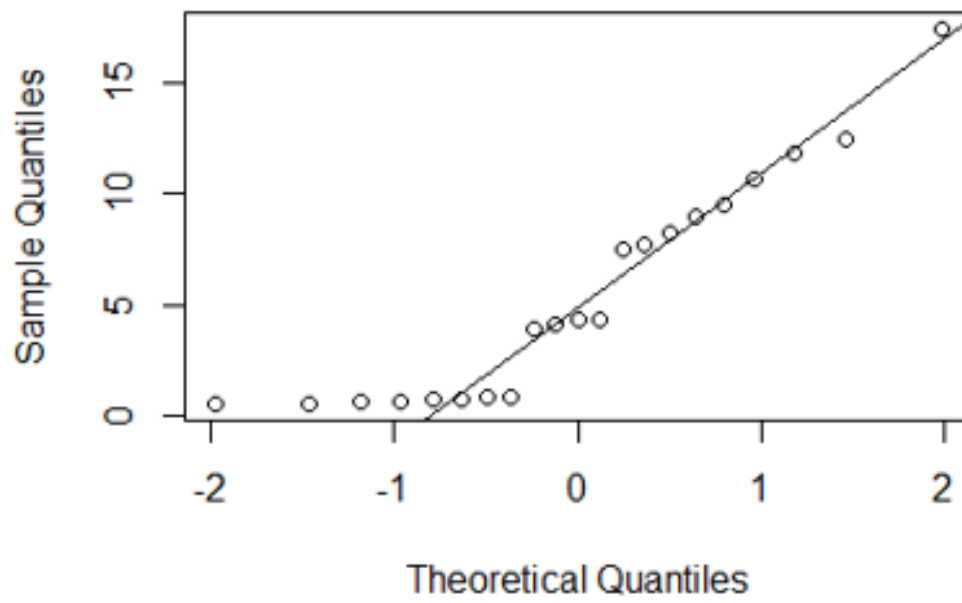
Figure C33 Left wheel track_Eight months after application of HDP foams

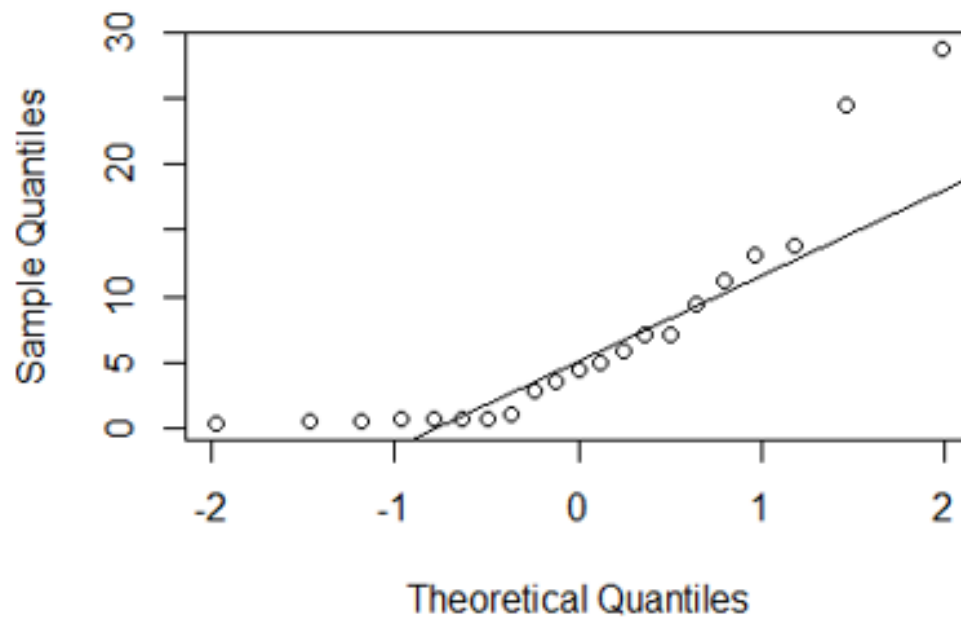
Figure C34 Right wheel track_Eight months after application of HDP foams

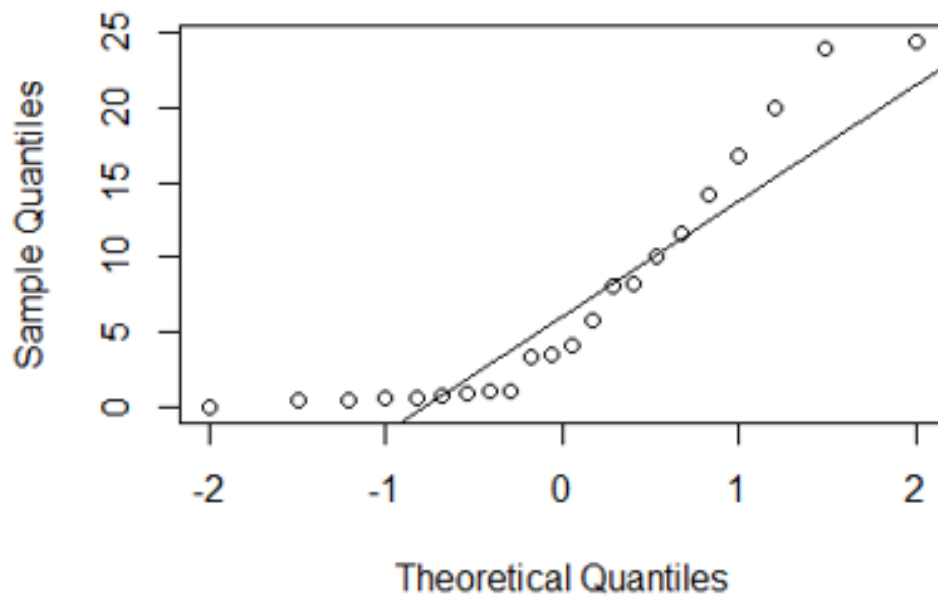
Figure C35 Left wheel track_Nineteen months after application of HDP foams
